EARTHEN DAM IRRIGATION SCHEMES IN TIGRAY, ETHIOPIA

DEVELOPMENT OPPORTUNITIES VERSUS SUSTAINABILITY CHALLENGES

Eyasu Yazew¹⁺², Herman Depeweg¹ and Mitiku Haile²

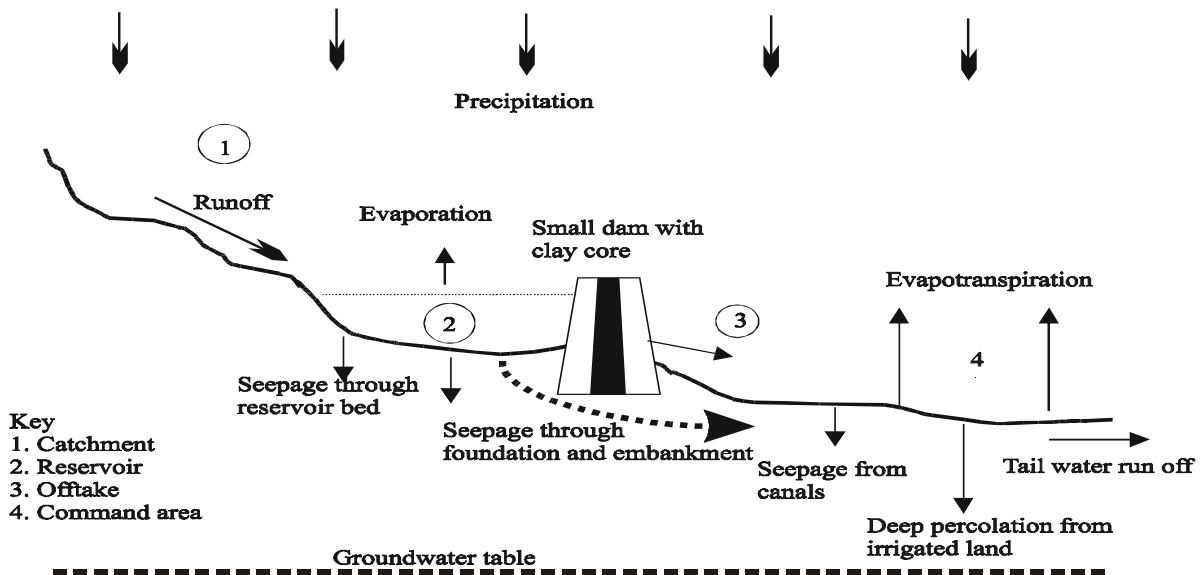
Figure 2 View and major hydrological processes of an earthen dam project

The earthen dam irrigation schemes in Tigray consist of a catchment area, a reservoir, an earthen dam (embankment), and a command area with irrigation and, in some cases, drainage infrastructure. A view of the earthen dam projects is presented in Figure 2. As a result of precipitation, water flows from the catchment area (1) to the reservoir (2); the reservoir supplies irrigation water (3) to the command area (4) (Figure 2). Usually the flow is larger than the quantity required by the crops to be irrigated, because water is also used by non-irrigated vegetation or is lost as evaporation and/or seepage from conveyance and distribution canals, by deep percolation from irrigated fields and as runoff at the tail ends (Bos and Wolters, 1994). In addition to the release of water from the reservoirs through outlet works, water also seeps through the embankments of these dams. Downstream farmers usually divert this water for irrigation.

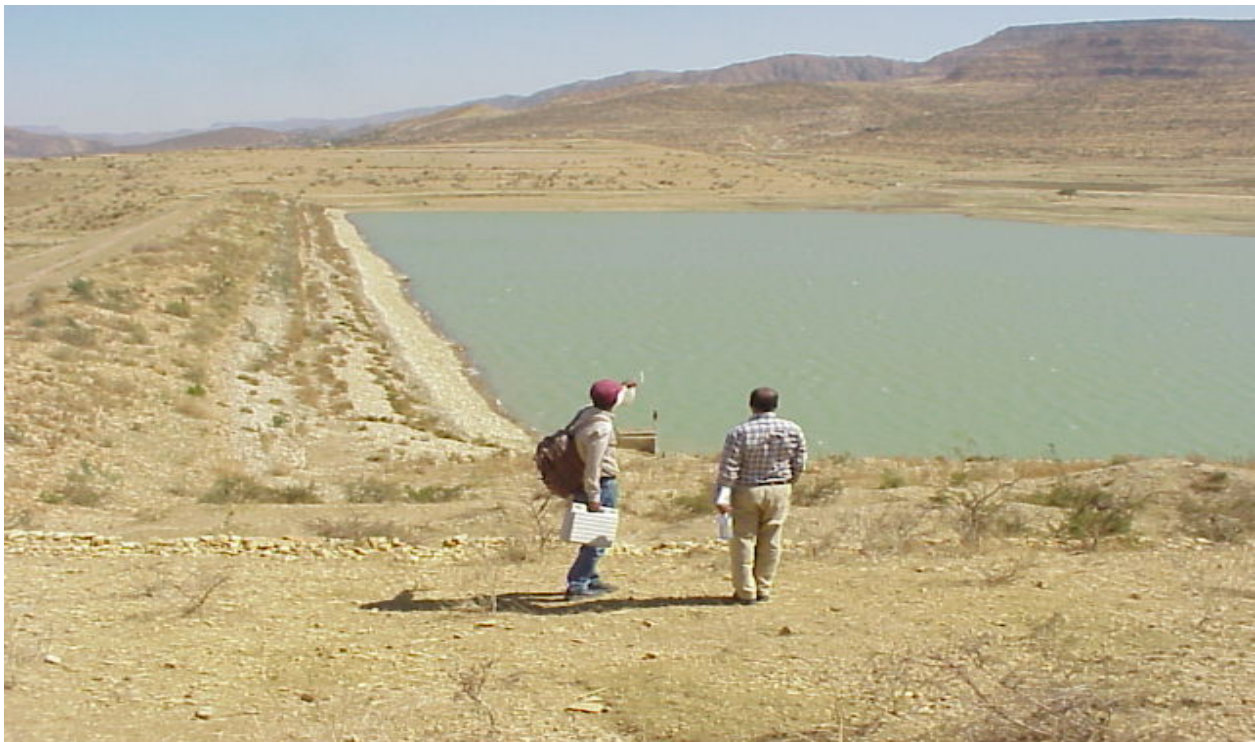
Figure 3 Partial view of the catchment area, reservoir and embankment of the Korir earthen dam

Most of the catchments are composed of steep slopes, which are prone to soil erosion because of runoff (Figure 3). As a result, the strategy has set a compulsory and intensive soil conservation and forestation programme in the catchment prior to the commencement of the construction of an irrigation scheme. The objective is to rehabilitate the degraded lands in the project area by constructing conservation works and planting millions of seedlings for soil protection and forest products. In this way, soil erosion and siltation of the earthen dams will decrease (CoSAERT, 1994). However, until now there are no cases of catchment rehabilitation prior to the dam construction. Priority was given to the construction aspects only and all the available labour was allocated to it. As a result, the rehabilitation program of most of the dams was started after completion of the construction works. There is a widespread fear in the region that reservoirs will be silted up before serving their design life. However, there are so far no systematic studies carried out to quantify the effect.

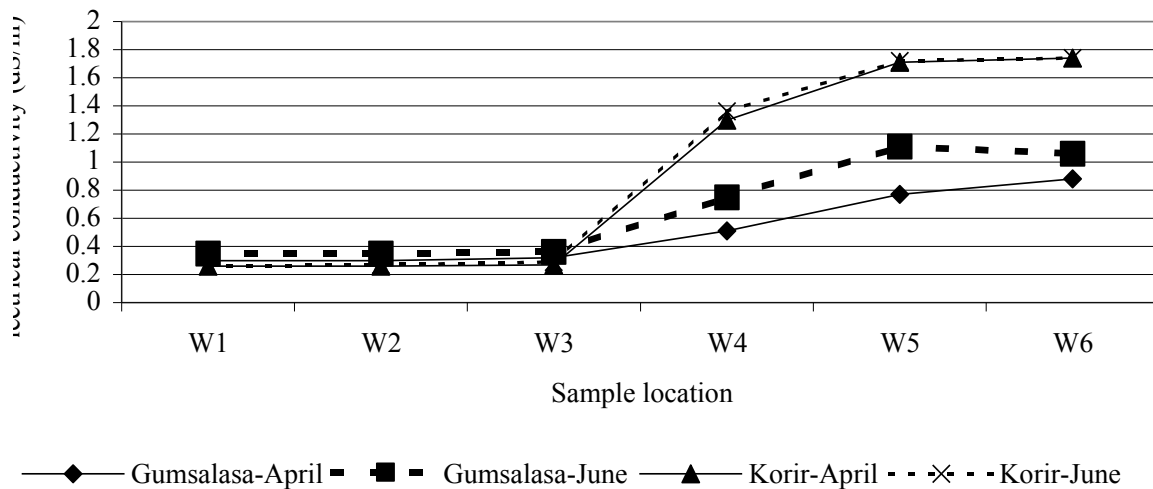
Figure 5 Salinity of irrigation water at different locations in the irrigation schemes

The surface water quality analysis of the study sites is presented in Table 5 and Figure 5. The result clearly indicates that there is insignificant difference in reservoir and proper canal water qualities of the two study sites. The difference is more pronounced in the quality of the seepage water.

The reservoir water of the irrigation schemes is generally of good quality. The slight variation in reservoir salinity of the two study sites is possibly the result of the catchment soil salinity. As indicated in Table 5, soil salinity of the catchment area of Gumsalasa is slightly higher than that of Korir. It is therefore possible that the runoff from the Gumsalasa catchment carries more salt than Korir. The variation in salinity between the reservoir water and the irrigation water delivered through the proper canal infrastructures is very small in both study sites (Figure 5). Based on the result, the reservoir and proper canal irrigation water is categorized as suitable for irrigation of all soils and crop types.

The quality of the seepage water is poor compared to the proper canal water and varies greatly between locations in the irrigation scheme and irrigation seasons. As it can be seen from the results, the seepage water in the study sites is categorized as high saline and allows only the growth of salt tolerant crops. The source of the seepage water is mainly the reservoir. However, it is further supplemented by seepage from adjacent irrigation canals and drainage from irrigated fields. These contribute to the increase in salinity level due to the leaching effect. As a result, unlike the proper canal water, the quality of the seepage water shows a high variation and decreases from top to bottom (i.e., from the source to the irrigated field and the downstream area). The soil type plays a very important role in leaching. The irrigated areas of Gumsalasa are dominated by heavy soils (Vertisos) while Korir is dominated by medium soils (Cambisols). The leaching efficiency depends on the soil type and is generally higher in medium soils than heavy soils (Arar, 1971). This indicates that medium soils have higher capacity to leach the salt available in the soil profile. The infiltration analysis in the study sites have resulted in a basic infiltration rate of 8 mm/hr and 12 mm/hr for heavy soils and medium soils respectively. This might also contribute to the high leaching efficiency at Korir. As a result, Korir shows a higher salinity level of the seepage water.

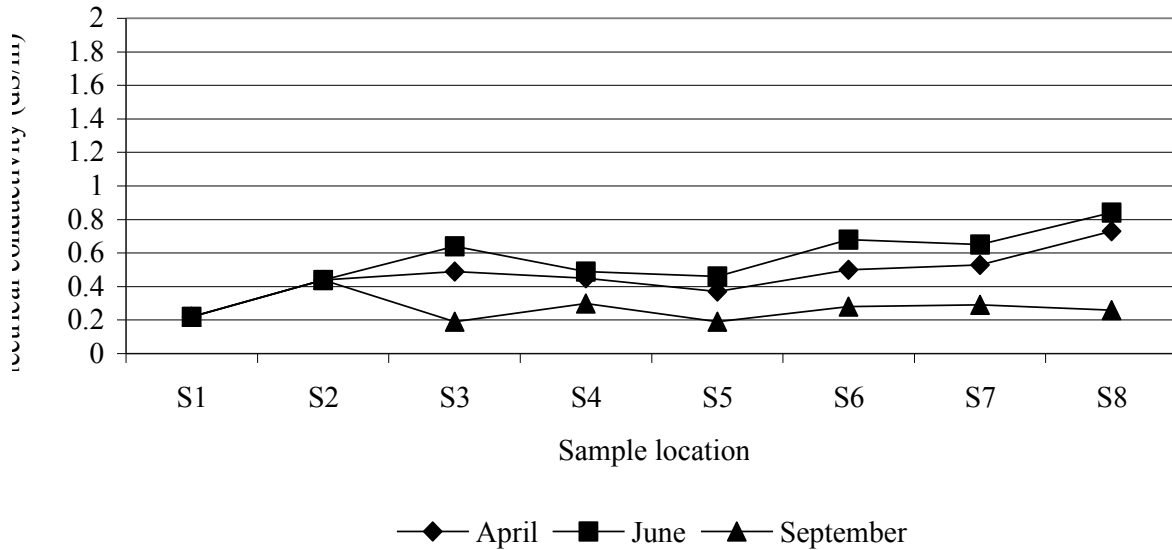
Figure 6 Soil salinity of different locations at Gumsalasa irrigation scheme

The soil salinity analysis of the study sites reveals a very low electrical conductivity depicting the low level of salinity (Table 5, Figure 6 and Figure 7). Salinity is generally higher at Gumsalasa than Korir. In both schemes, salinity increases over the irrigation season due to the higher evapo(transpi)ration that leaves salt in the root zone of the crops. Salinity of the secondary command area is also higher than the primary. This is due to the high salinity of the seepage water used for irrigating the secondary command. Compared to the rainfed field, which is considered as a control, the salinity of the study sites have shown an increase of about 68% - 282% at Gumsalasa and 4% - 280% at Korir during the irrigation season. As it could be seen from the results, the soil salinity of the schemes drops immediately after the rainy season because of the leaching of the soluble salts. The soil salinity of the schemes generally commensurate with

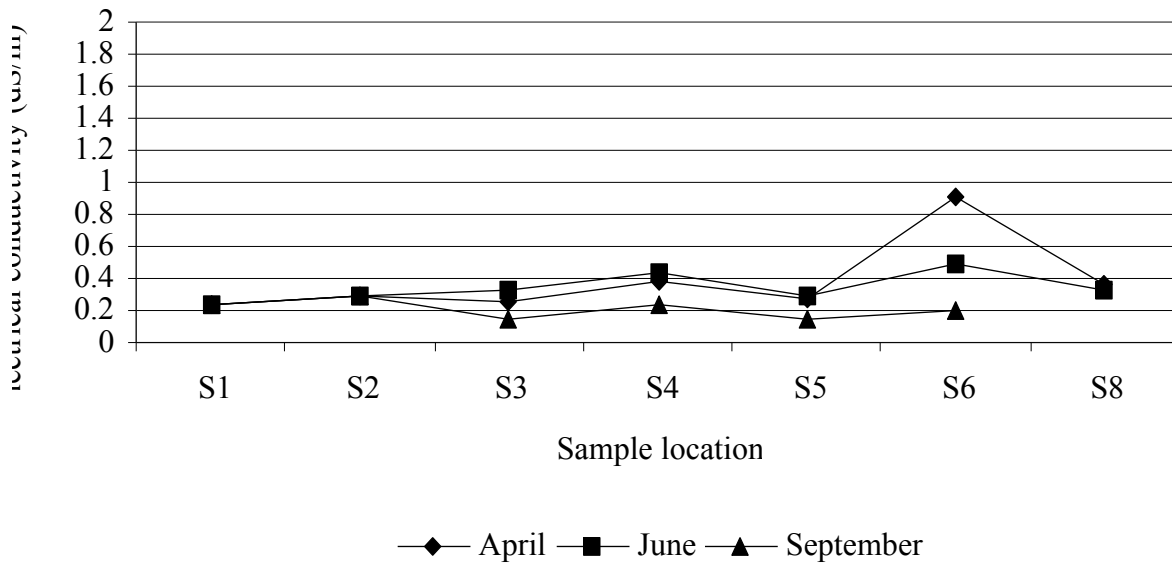
Figure 7 Soil salinity of different locations at Korir irrigation scheme

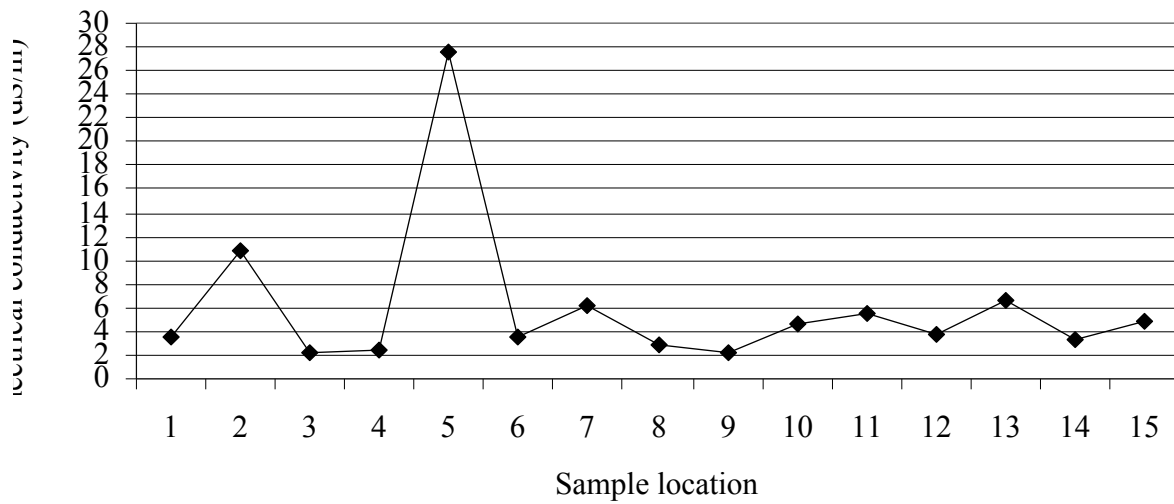
Figure 8 Localized soil salinity at Gumsalasa at different locations

The results in Table 5 give the general condition of the salinity in the study sites. However, observation of the schemes shows the presence of high level of localized salinity especially at Gumsalasa. These localized saline areas were sampled and assessed separately. The results generally exhibit the presence of slightly saline to extremely saline conditions (Figure 8 and Figure 9). The first 9 samples were taken from the primary command area while the rest belong to the secondary. The peak value in Figure 8 corresponds

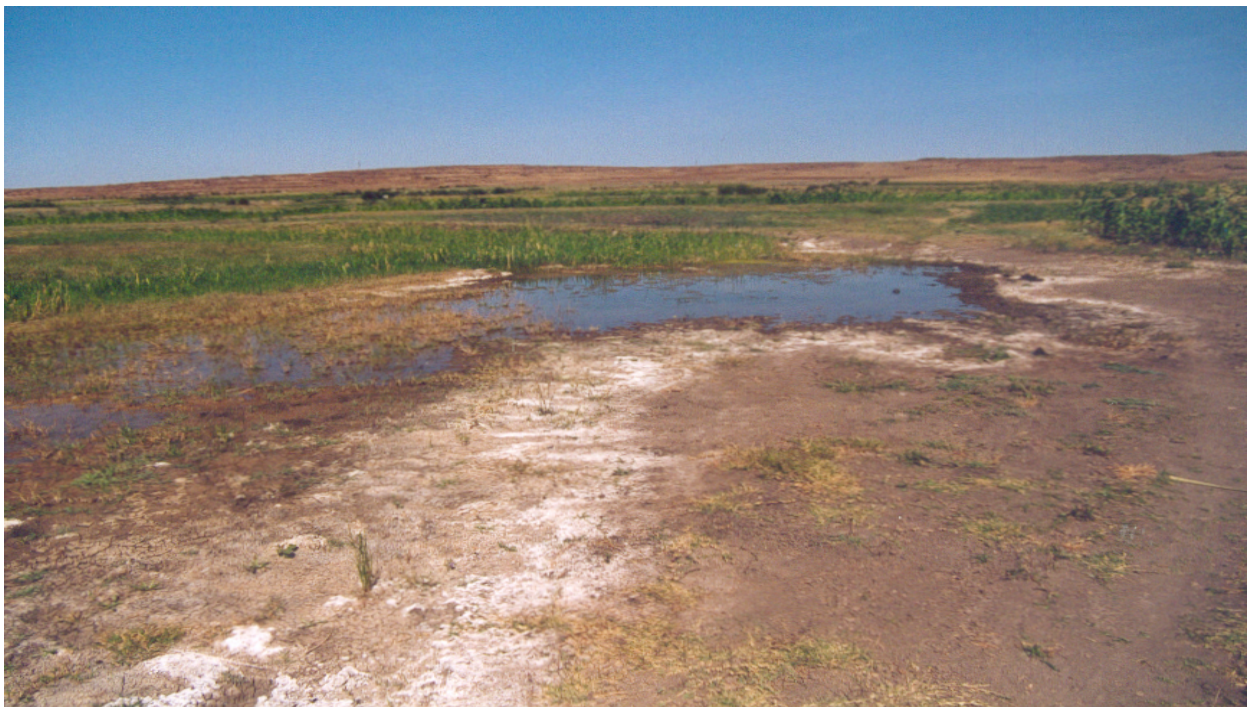
Figure 9 A salinized irrigated field at Gumsalasa

to the field shown in Figure 9. This field is at the moment almost abandoned from agriculture.
