TIGRAY LIVELIHOOD PAPERS No. 5

Household water harvesting structures in Geba catchment

Fekadu Wondumagegnehu, Alemtsehay Tsegay, Dereje Ashebir,
Hailemariam Tekie, Addisu Gebre, Mewael Kiros, Sam Geerts, Dirk
Raes, Jan Nyssen, Seppe Deckers
September 2007

VLIR – Mekelle University IUC Programme

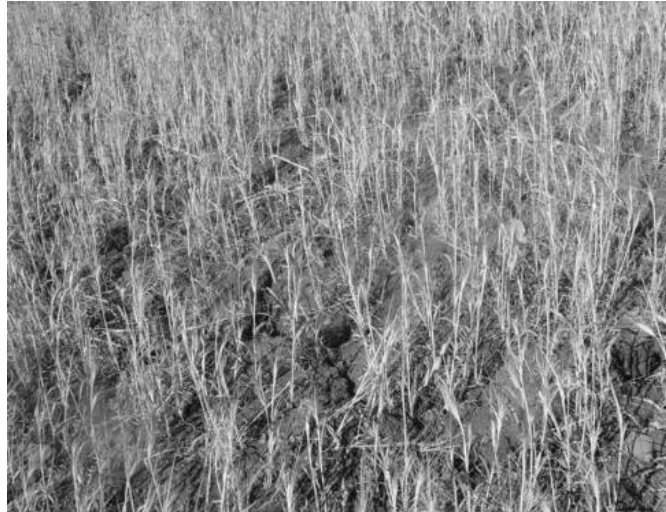
Picture 1. Aborted wheat crop due to low soil moisture at Adi Gudom

Continuous moisture stress in the region, particularly over the last twenty years, has directly resulted in severe food shortages and decline in overall food production (Picture 1). It has also affected seed stocks and decimated livestock herds while forcing hundreds of thousands of people to migrate.

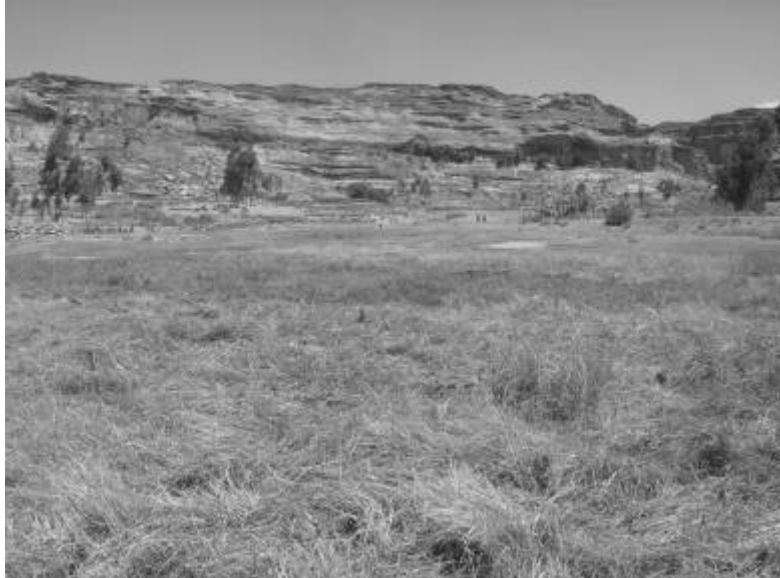
Picture 2. Shallow wells sites at Maydenglat

All the shallow wells (Picture 2) are located at places with shallow water tables, mostly at the valley bottom, and are excavated by hand shovel below the water table level of the dry season. Hundreds of hand dug wells have been excavated in the project area and their number is expected to increase in the coming few years as they are seen as an escape from poverty by many farmers.

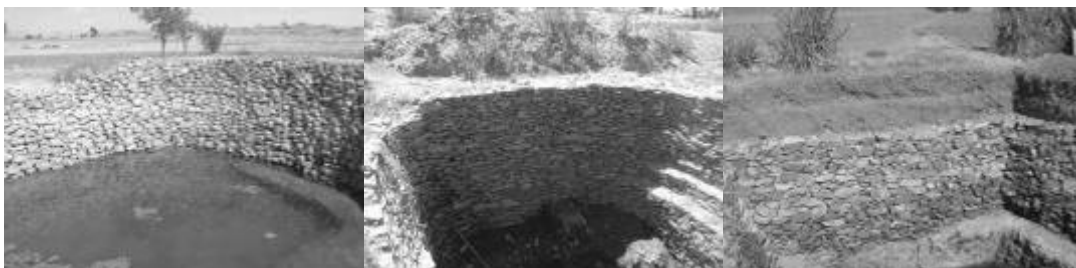
Picture 3. Structural view of hand dug shallow wells

Hand dug wells were designed with a size of 4 m by 4 m at the mouth with varying depth depending on the water level and geographical position. The observed size, however, varies considerably due to the differences in shape (circular, rectangular or square), depth, width, slope of the side walls (see Picture 3). Most of them are rectangular or circular with a diameter ranging from 2 to 8 m at the mouth. The variations in depth between different hand dug wells

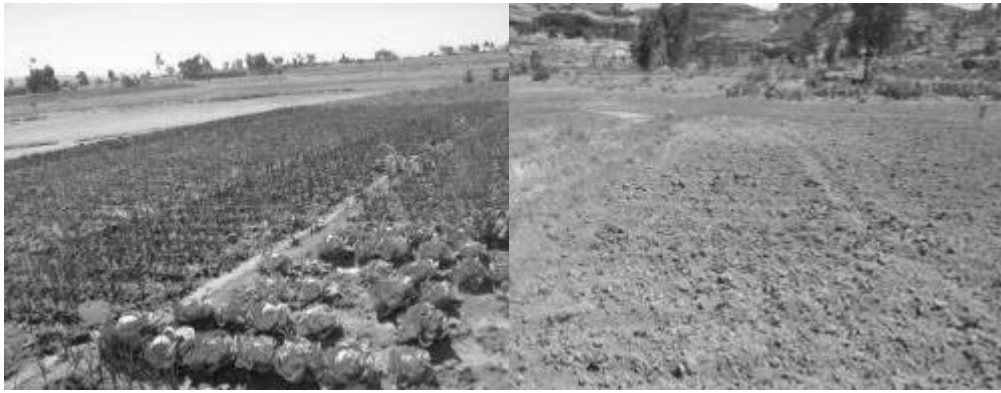
Picture 5. Fields of farmers at Senkanet and Maydenglat where water is applied

The farmland brought under irrigation by individual farmers is ranging from 36 m² to 2500 m² (Table 3; Picture 5) and are independent of the productivity of the well. The rate of reference evapotranspiration of the sample area for the period that irrigation activities are taking place (January – June) is ranging from 3.6 to 6.6 mm and averaging 4.9 mm (Fig. 3). According to Doorenbos and Pruitt (1977) the Kc value for the initial, mid and late season stages of tomatoes, the crop that most cultivated under irrigation, is 0.6, 1.15 and 0.7, respectively. Thus, taking into consideration the crop Kc and the peak and the average reference evapotranspiration of the site during the crop growth period, the average and peak daily water requirement of the crop is 4.3 and 7.1 mm. If the water yield of the wells had been taken into consideration to decide the size of the land that had been brought under cultivation it would have been quite different from that of the current cultivable land (Table 3). Nearly half of the sampled farmers brought more land under cultivation than what should have been brought if the water yield of the well had been considered. It is vividly seen that many of their crop is grown under water stress conditions, and a relatively lower yield is expected from their field. There are also farmers who failed to fully exploit their well water, though only few (Fig. 4).

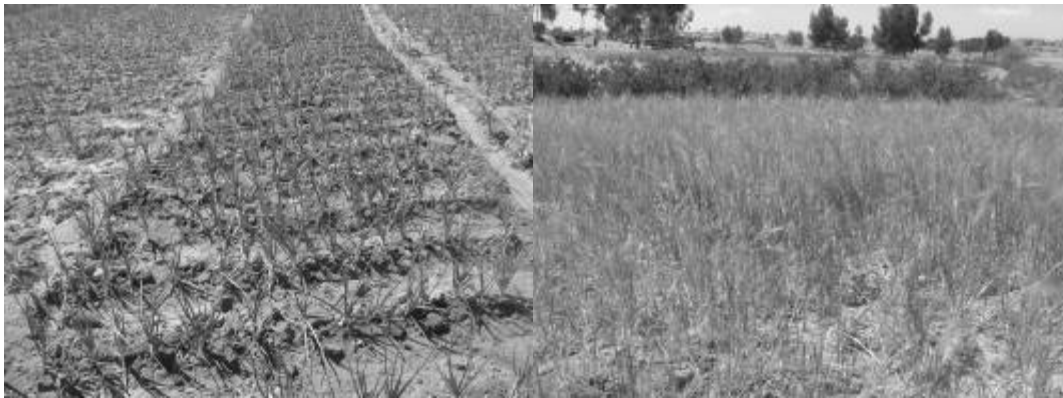
Picture 6. Basin and flood irrigation of respectively onion and barley

The current practice of water application has many drawbacks, one of which is the method of irrigation that varies. Farmers are using flood, furrow and basin irrigation depending on the types of crops they are irrigating. These irrigation methods differ in performance. For instance Yavuz (1993) tested the application efficiencies of sprinkler and open end furrows and he found that sprinkler irrigation and open end furrows had the application efficiencies of 92 % and 67%, respectively. Similar studies by Çetin (1997) revealed that the water use efficiency for furrow irrigation is low as compared to drip and sprinkler irrigation. When field application efficiencies of the irrigation methods practiced in the project area are considered, they may not exceed 35 % indicating there is substantial loss of water, which would otherwise remain unexploited or would be used for irrigating more land.

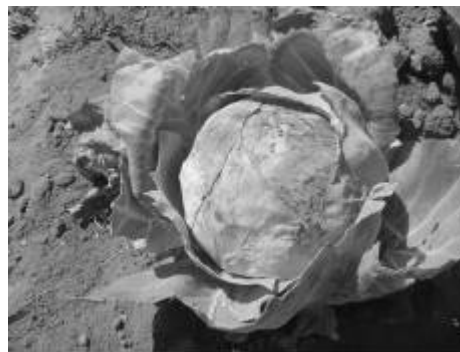
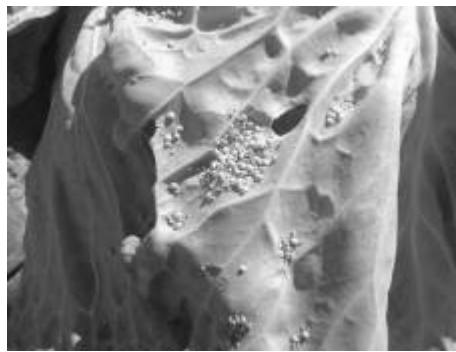
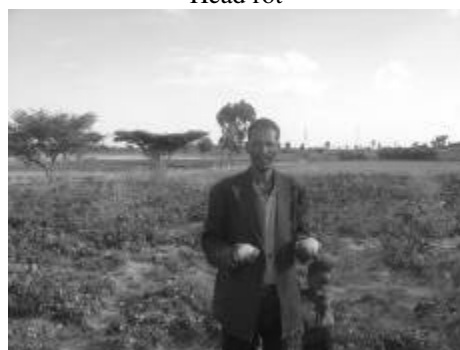
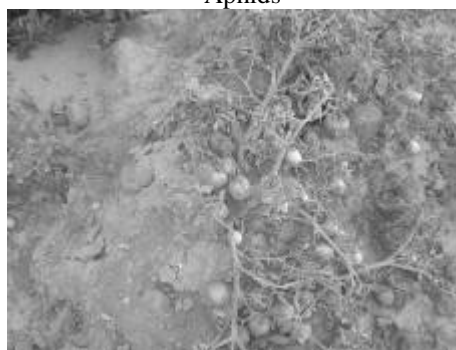
Head rot

Aphids

Frost damage

Leafs eaten by larvae exposed the fruit to sunburst

Picture 7. Vegetable crops affected by diseases, insect pests and frost damage

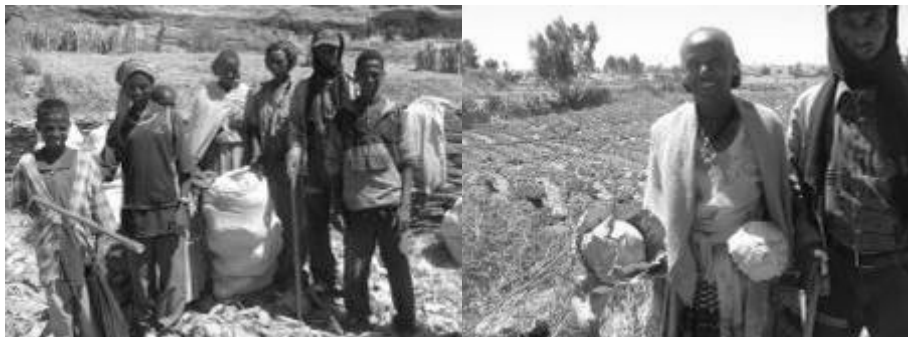
Picture 8. The advantage of hand dug wells: cabbage ready for market at Maydenglat

Beneficiaries expressed that the earning of individual farmers have greatly improved (Picture 8). It brought food security at household level and improved the living standard of farmers owning hand dug shallow wells. They have changed their feeding style both in terms of frequency and quality and managed to buy new dresses for them and their children. These in turn have brought a change in their health status. Diseases related to malnutrition declined.

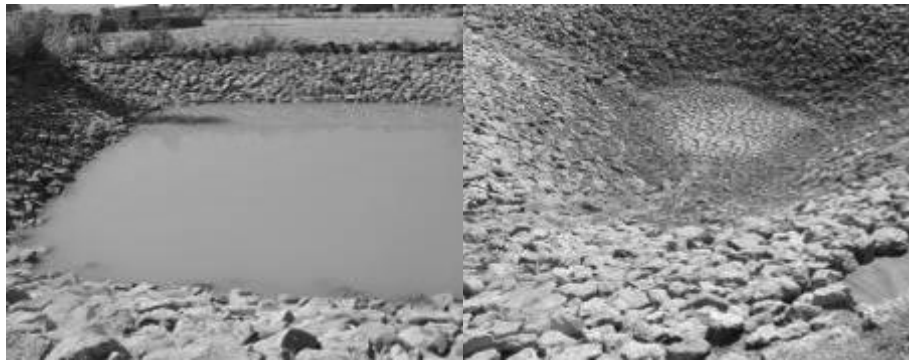
Picture 9. An overview of lined and rip-raped ponds

The size and capacity of the ponds vary, though the majority of ponds have a design size of 12m x 12m x 2.5m with a potential water holding capacity of 184 m³ (see appendix). The harvested water is designed for supplementary irrigation of 2000 m² of land after the cease of the rainfall. However, the actual water holding capacity of most ponds is below the designed potential (Table 4). There are many reasons for the observed differences such as lack of skilled man power, flaws in implementing the design of the structure, beneficiary's perception and problems of lining materials including substandard or punctured polyethylene materials (Picture 9).

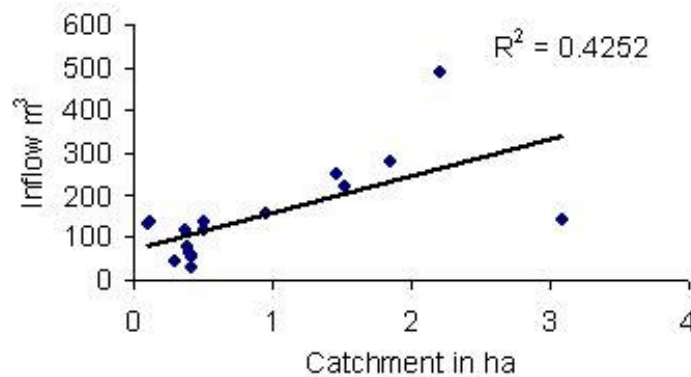
Fig. 6. Runoff and catchment area relationships estimated from 17 ponds

the pond was not considered in most of the visited sites. As it is shown in Fig. 6, there is a linear relationship between catchment areas and estimated runoff produced by the catchment areas of 17 ponds. The relationship, however, is not strong indicating that it is not only the size of the catchment that determines the volume of runoff, but also factors like the characteristics of rainfall (intensity, duration, and distribution), catchment characteristics (shape, drainage density, and topography), soil characteristics (infiltration capacity, permeability, texture and depth), land use and vegetation cover. As a consequence catchments of different sizes can produce the same amount of runoff and vice versa (Fig. 6).

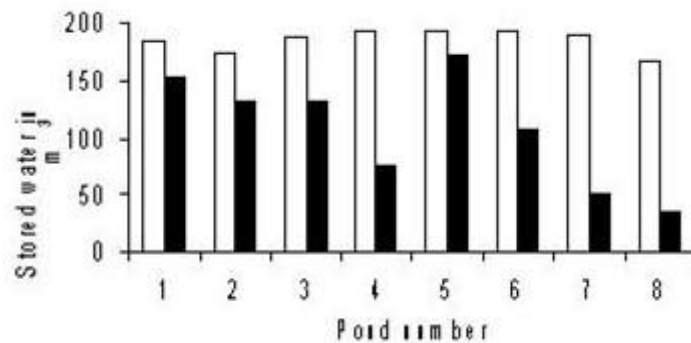
Fig. 7. Actual water holding capacity (□) and water level of ponds (■) when the rainfall was ceased

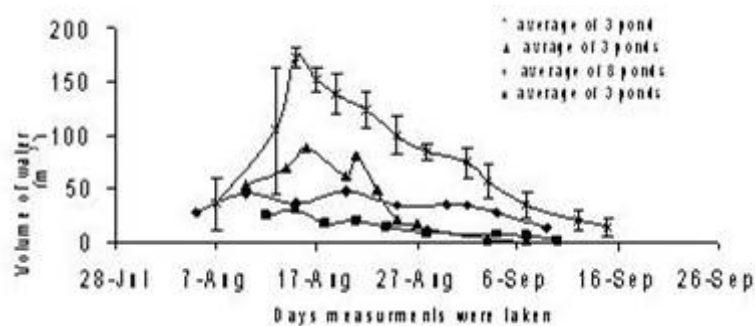
Fig. 9. Volume of water in the unlined ponds at different time during the rainy season

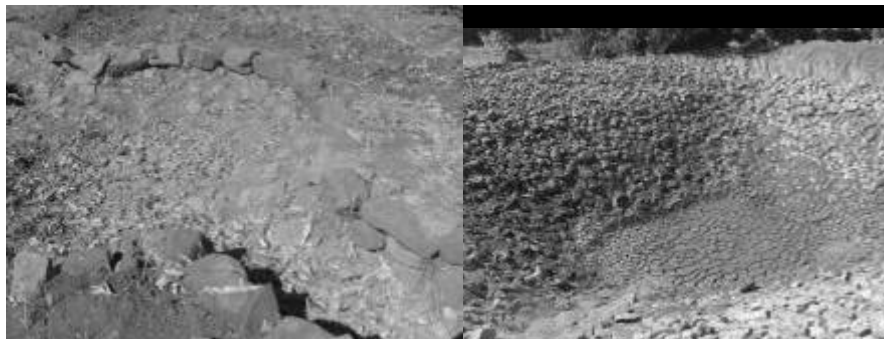
Picture 11. Silt trap structure and silt deposit in pond

Many of the ponds had little sediment that could easily be removed by farmers and siltation was not seen as a serious problem by many farmers. Some of the dried ponds had a sediment load of nearly 10 cm thick. Nearly all observed ponds have a silt trap (Picture 11), but none of them met the designed dimension, 2.5 x 2.5 and 1.5 m depth. However, the efficiency of these silt traps was measured in nearly 30 ponds and it was found that they reduced sedimentation on average by more than 60% (Table 6).
